# Casualty Information

Information from DNV to the maritime industry No. 5 December 2007

## Crankpin bearing running hot

Ship type: Any    Size (grt): <1,000    Year built: 2005

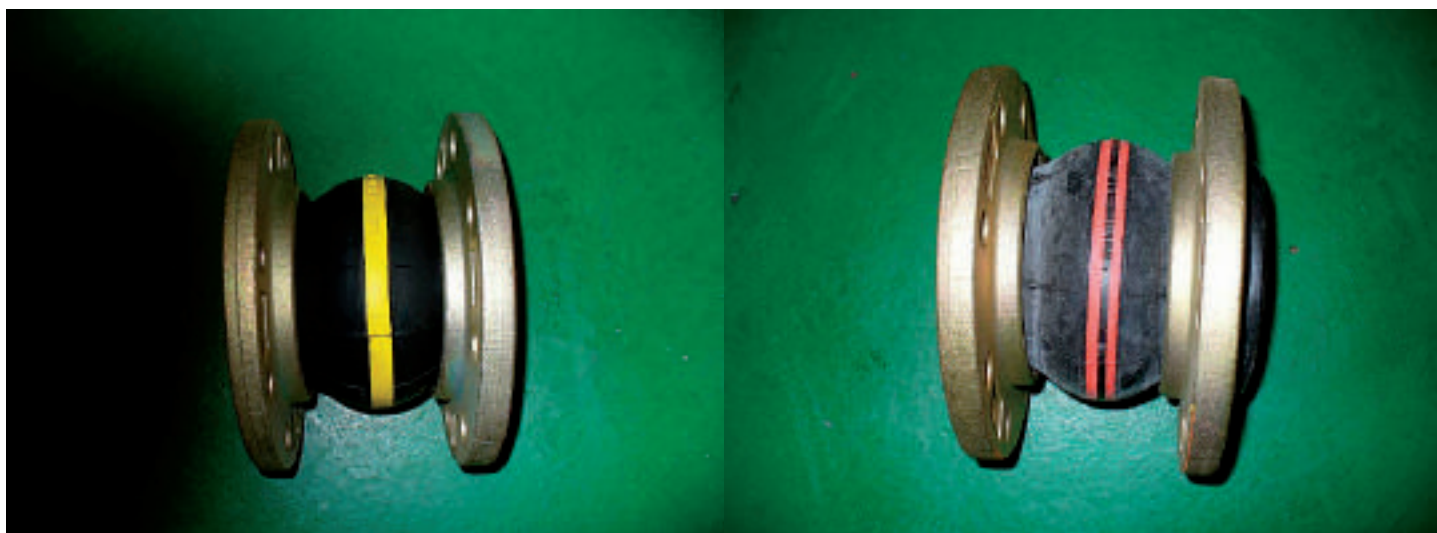
Fig. 1: Colour coded rubber expansion joints.

Investigation after the accident revealed that rubber particles of various size had blocked the lubricating oil system, originated from a disintegrated rubber expansion joint of the lubricating oil system.

It was confirmed that the manufacturer of such rubber expansion joints has separate specifications for various use of the joints, and the joints are consequently marked with different colour codes, see Fig. 1.

In this case an expansion joint intended for fresh- and sea-water cooling systems had been applied for the lubrication oil system from the new-building stage, causing disintegration of the rubber, which caused blocking of the lubrication oil system.

1. Specific requirements or limitations for different applications of rubber expansion joints on board may exist, designated by the manufacturer's colour codes.
2. Possible operational consequences by application of rubber expansion joints with wrong colour code, as in this case.

Colour codes as mentioned above may not necessarily coincide with the generally applied colour codes for freshwater, seawater, fuel oil and lubricating oil systems on board vessels.
